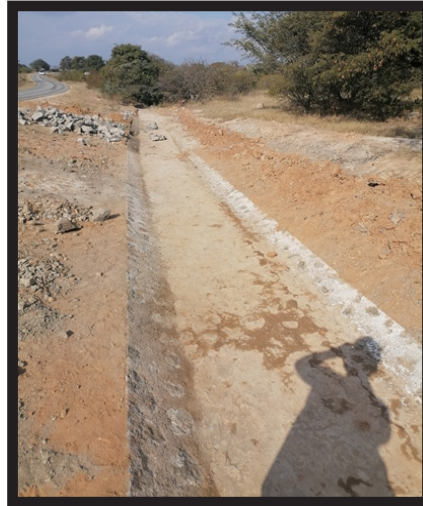
Construction of erosion protection works has been on going, along the recently surfaced pavement and on the 2019 constructed phase. Stone pitching is being done with skill and innovation, as shown in the photos, in areas where there is usually high velocity road runoff. Stone pitching protects culverts, headwalls and pavement base layers from erosion and the amount of suspended silt is reduced as water runs off on a protected base.

Stone pitching in progress.

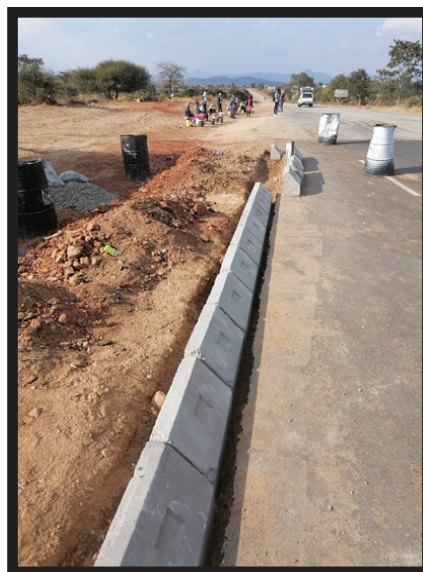
Surfacing works for the last 14km have been completed and the road is now fully trafficked to the Mhandamabwe intersection, which is looking superb. Other works that are still in progress include laying of kerb stones and L channels. Kerb stones are being placed on 25mm thick concrete bedding and haunched with concrete for support. Most of the laying that has been done so far has been giving a striking visual impact helping vehicles to stick to their intended path.

Lining kerb stones at Mhandamabwe intersection.

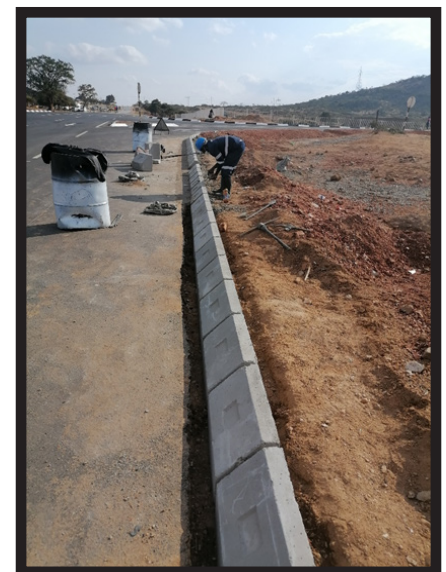
Mhandamabwe intersection last stretch of kerb stones being installed.
